Washington State Enhanced Hazard Mitigation Plan

Hazard Mitigation Best Practices

A compilation of the Hazard Mitigation Best Practices in the State

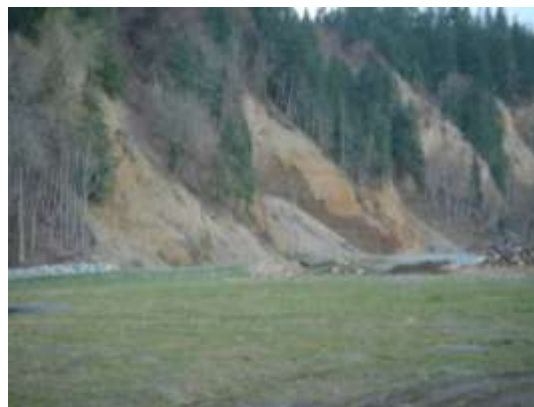
View from acquired properties across the river from the landslide area. As these slopes become saturated during periods of significant rainfall, large landslides can fall into the river's channel thereby causing it to migrate towards the properties. Structural techniques (levees) placed near the River's normal edge have been largely ineffective against preventing the channel migration and protection during significant flooding events.

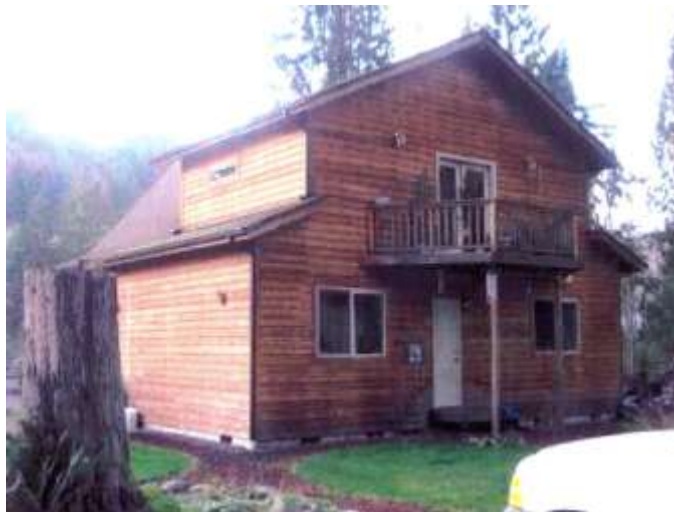
***Before the Acquisition –
Home is subject
future flooding
and channel
migration***

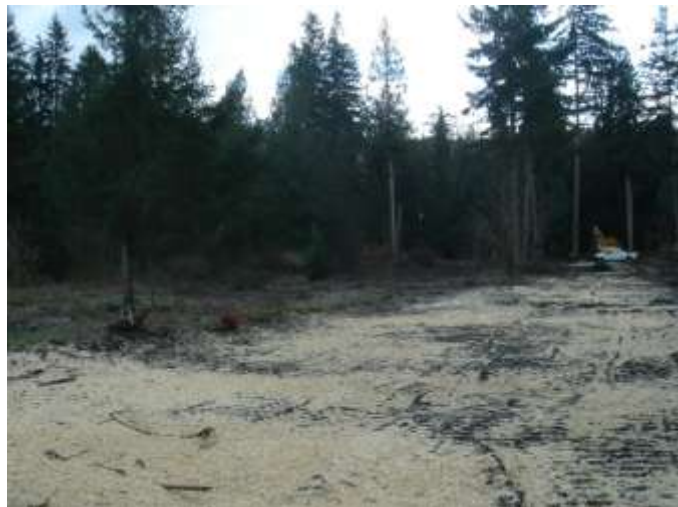
***After the Acquisition
and Demolition –
The property
contributes to
natural and
beneficial floodplain
function***

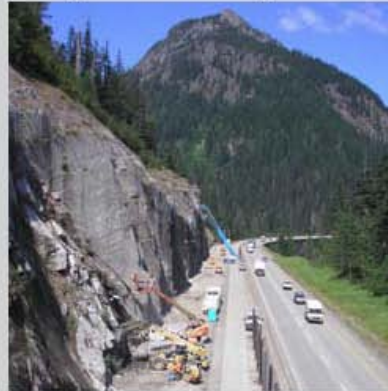
Scaling at Snoqualmie Pass.

The highway passes through widely varying geology and mountainous terrain requiring highway cuts in bedrock, some approaching 100 feet in height. The exposed geology has naturally occurring planes of weaknesses that often create a potential risk of rockslides and rockfalls. In the 1960s and 1970s, wide ditch catchments and concrete barriers were typically employed to minimize the risk of rockfall reaching the traveled lanes.

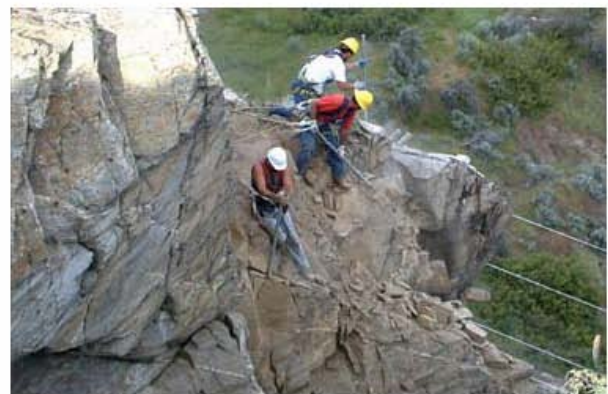
Scaling.

The WSDOT Geotechnical Division works directly with the Region Maintenance and Materials Engineer's offices to identify the locations of rock slopes where risk reduction scaling would be beneficial. Typically these slopes have chronic rockfall problems with rocks reaching the highway numerous times during the year

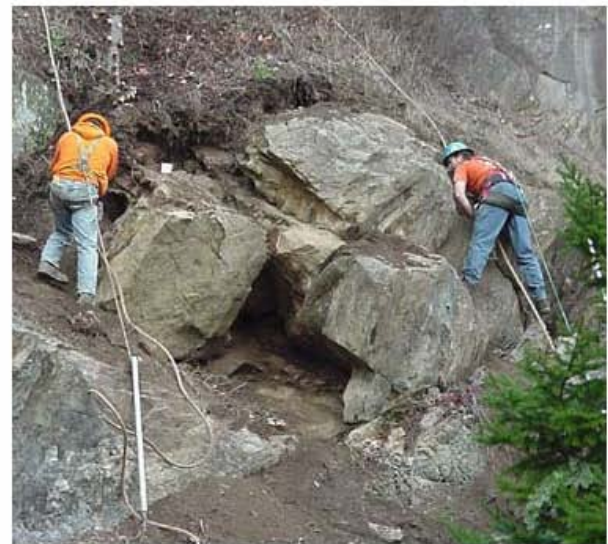
Scaling.

During the 2007-2009 biennium, 31 high priority rock slopes were identified as candidates for risk reduction scaling. Based on a biennial budget of \$1.5 million, eight slopes on SR 2, 7, 20, 21, and 261 have been successfully scaled. An additional 44 slopes have been identified across the state and another \$1.5 million has been allocated for risk reduction rock slope scaling in the 2009-2011 biennium.

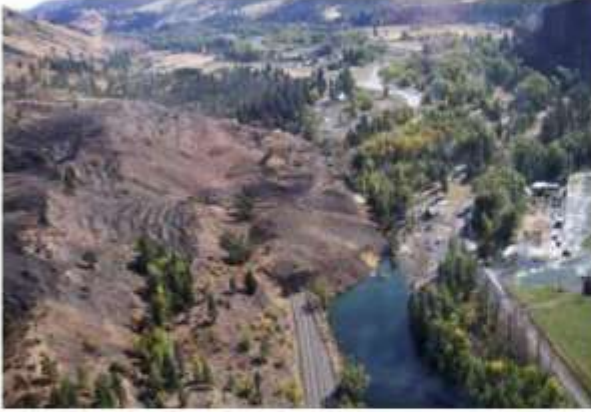
Landslide – The vertical and horizontal displacement of a soil mass, under the influence of gravity, within a slope or embankment. Generally landslides can be divided into two categories based on failure geometry. Those landslide categories are circular and sliding block failures. The rate of movement of landslides can vary from very slow moving to very rapid.

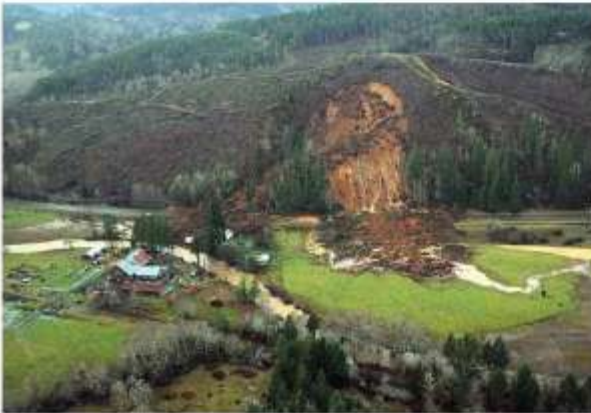
Debris Flow – A rapidly moving fluid mass of rock fragments, soil, water, and organic material with more than half of the particles being larger than sand size. Generally debris flows occur on steep slopes or in gullies and can travel long distances. Typically, debris flows result from unusually high rainfall, or rain on snow events.

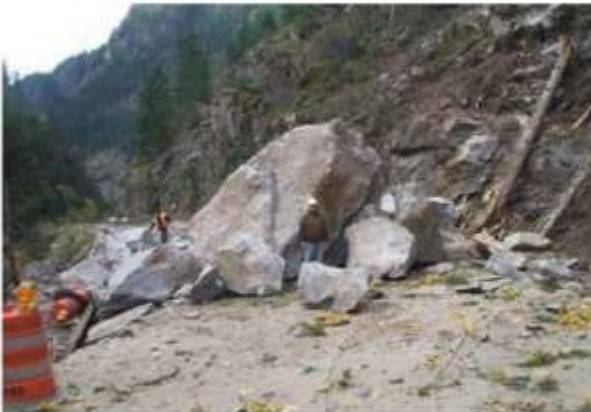
Rockfall – The fall of newly detached segments of bedrock of any size from a cliff or steep slope. The rock fall descends mostly through the air by free fall, bouncing, or rolling. Movements are very rapid to extremely rapid, and may not be preceded by minor movements.
